750 ACE PUMP HYDRAULIC SEAL REPLACEMENT KIT JM0061314

ACE PUMPS PART NUMBER: RK-BAC-75-M

Ace Pump Breakdown and Hydraulic Seal Replacement

J&M Part Number: JM0061314

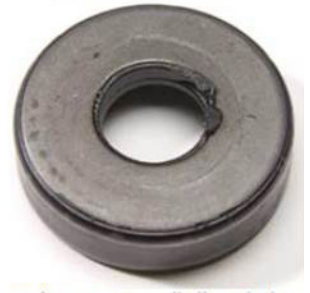
HIGH BACK PRESSURE IN THE RETURN LINE:

This is the most common cause of shortened motor seal life. the hydraulic motor seal is rated for 250 pssi of back pressure. However, a continuous return pressure of 100 psi or less is recommended for efficient operation and optimum seal life. The high return pressure is caused by restrictions in hoses, fittings, and tractor plumbing.

Seal lips pressed tight against the outer seal housing and shaft. There may also be grooves in the shaft where the seal lips touch.

The best way to minimize return pressure is to return oil directly back to the tractor reservoir. Most tractor manufacturers now offer a Low Pressure RETURN Port option for this purpose. Contact your dealer for the specific options available for your tractor model. Proper hydraulic hose sizing is also important to minimize restriction. An open hose coupling may also be used to reduce restrictions in the return line. Ace recommends 1/2" hose for 200 Series motors and 3/4" hose for 300 series motors. The hoses should be sized larger if individual lengths exceed 15 feet.

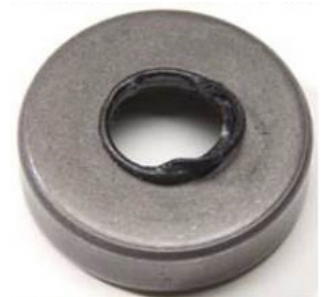
PRESSURE SPIKE:

System pressure spikes may also damage the shaft seal and cause leakage. Spikes in the 3000-5000 psi range may result from improperly synchronized hydraulic valves or quick couplers coming unplugged during operation.

The seal lips are pressed tight against the outer seal housing and form a right angle between the seal housing and the shaft. In severe cases, the seal lip material may be extruded between the front seal casing and the shaft.

Using a Low Pressure Return Port prevents spikes by keeping the return line open back to the reservoir at all times. If not using a low pressure return, the pump should always be turned off by moving the lever to the Float position. When moved to Float, the oil supply valve is shut but the return valve stays open.
