# 155 ACE PUMP HYDRAULIC SEAL REPLACEMENT KIT JM0061310

## ACE PUMPS PART NUMBER: RK-BAC-75-HYD-L

## Ace Pump Breakdown and Hydraulic Seal Replacement

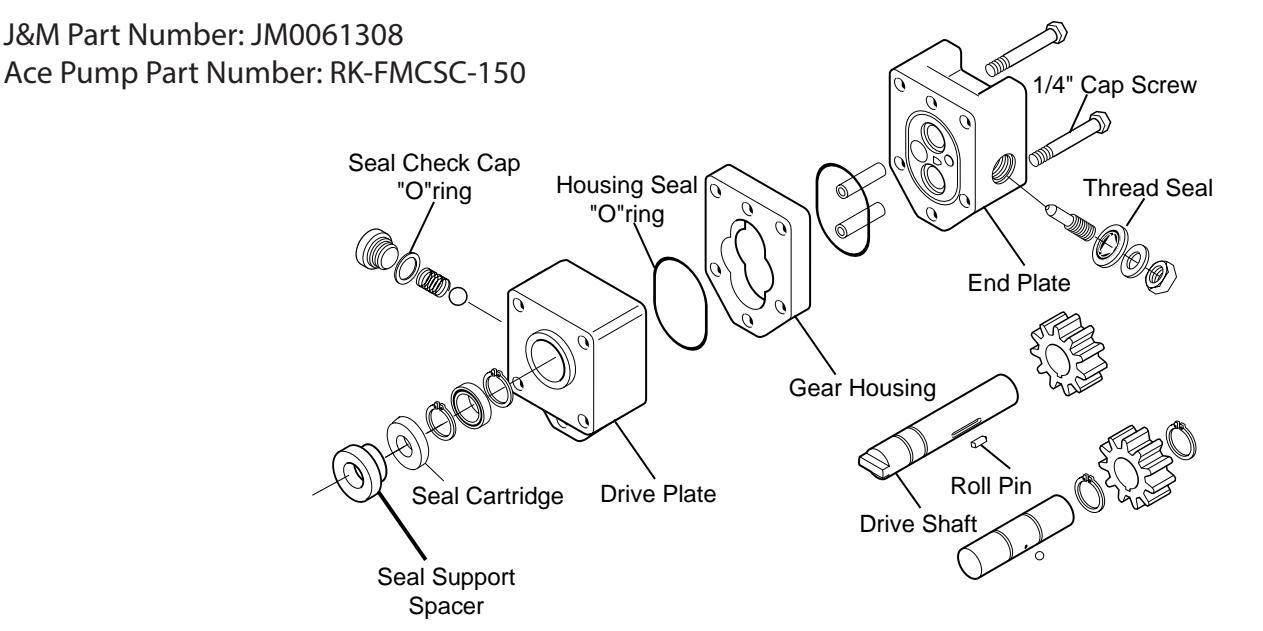
**Note:** The seal cartridge come on an installation bullet with a small diameter for storage and a loarger diameter for installation. The seal lips curve towards the larger diameter when properly installed on the bullet. The seal should remain on the bullet until installation for best results.

- 1. Remove motor from pump by removing four cap screws.
- 2. Remove seal retaining ring from drive plate if installed and discard.
- 3. Remove two 1/4" cap screws (200 series) or four 3/8" cap screws (300 series).
- 4. Scribe a line on motor casing (end plate, drive plate, housing), note orientation, and pull apart.
- 5. Remove idler gear/shaft assembly, drive gear, and drive shaft dowel pin. Note: Failure to remove dowel pin will result in bushing damage.
- 6. Press or tap (non-marring hammer) drive shaft/bearing assembly, and seal cartridge out of drive plate.
- 7. Remove and discard old "O" rings and seal cartridge. Check shaft for wear or grooving under seal and replace if damaged.

- 1. Place drive shaf/bearing assembly in drive plate.
- 2. Apply a thin film of hydraulic oil to the seal lips and bullet. Insert seal/bullet assembly over shaft tang. Press seal by hand over the installation bullet until the seal casing touches the drive plate.

- 3. Place a 3/4" (200 Series) or 15/16" (300 Series) deep socket over seal and press or tap into seal cavity until seated.
- 4. Remove the installation bullet and discard.

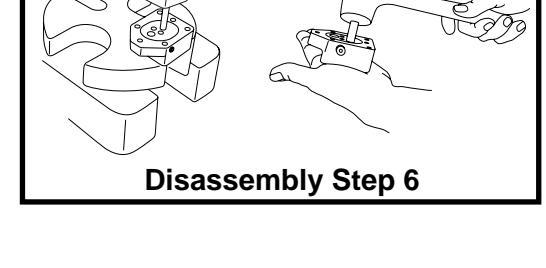
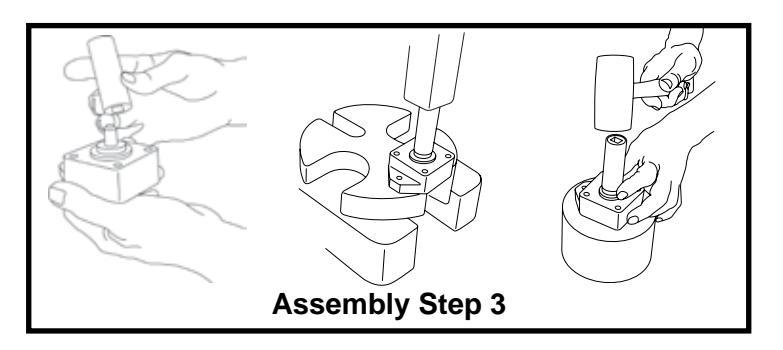
- 12. Position coupler in pump shaft slot and seal support spacer around coupler. **Note:** The smaller diameter of the 200 series spacer must face the hydraulic motor. Fill the remaining area of the coupler/spacer cavity with coupler grease, align motor tang with coupler slot, and attach motor with four cap screws - torque 13 ft-lbs.

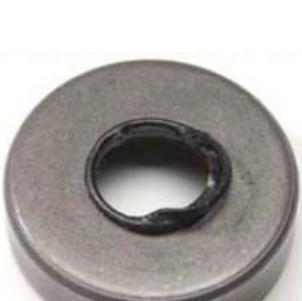
## HIGH BACK PRESSURE IN THE RETURN LINE:

This is the most common cause of shortened motor seal life. the hydraulic motor seal is rated for 250 pssi of back pressure. However, a continuous return pressure of 100 psi or less is recommended for efficient operation and optimum seal life. The high return pressre is caused by restrictions in hoses, fittings, and tractor plumbing.

Seal lips pressed tight against the outer seal housing and shaft. There may also be grooves in the shaft where the seal ips touch.

The best way to minimize return pressure is to return oil directly back to the tractor reservoir. Most tractor manufacturees now offer a Low Pressure REturn Port option for this purpose. Contact your dealer for the specific options available for your tractor model. Preper hydraulic hose sizing in also important to minimize restriction. A open hose coupling may also be used to reduce restrictions in the return line. Ace recommends 1/2" hose for 200 Series motors and 3/4" hose for 300 series motors. The hoses should be sized larger if individual lengths exceed 15 feet.

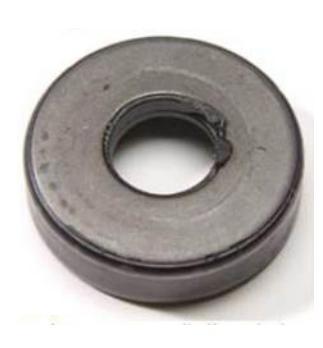
### **PRESSURE SPIKE:**

System pressure spikes may also damage the shaft seal and cause leakage. Spikes in the 3000-5000 psi range may result from imporperly synchronized hydraulic valves or quick couplers coming unplugged during operation.

The seal lips are pressed tight against the outer seal housing and form a right angle between the seal housing and the shaft. In severe cases, the seal lip material may be extruded between the front seal casing and the shaft.

Using a Low Pressure Return Port prevents spikes by keeping the return line open back to the reservoir at all times. If not using a low pressure return, the pump should always be turned off by moving the lever to the Float position. When moved to Float, the oil supply valve is shut but the return valve stays open.
